2012 Long-Term Monitoring
Annual Report
Metal Bank Cottman Avenue
Superfund Site
Philadelphia, PA

Prepared for:
Cottman Avenue Utility PRP Group

Prepared by:
ENVIRON International Corporation
Boston Massachusetts

Date:
February 2013

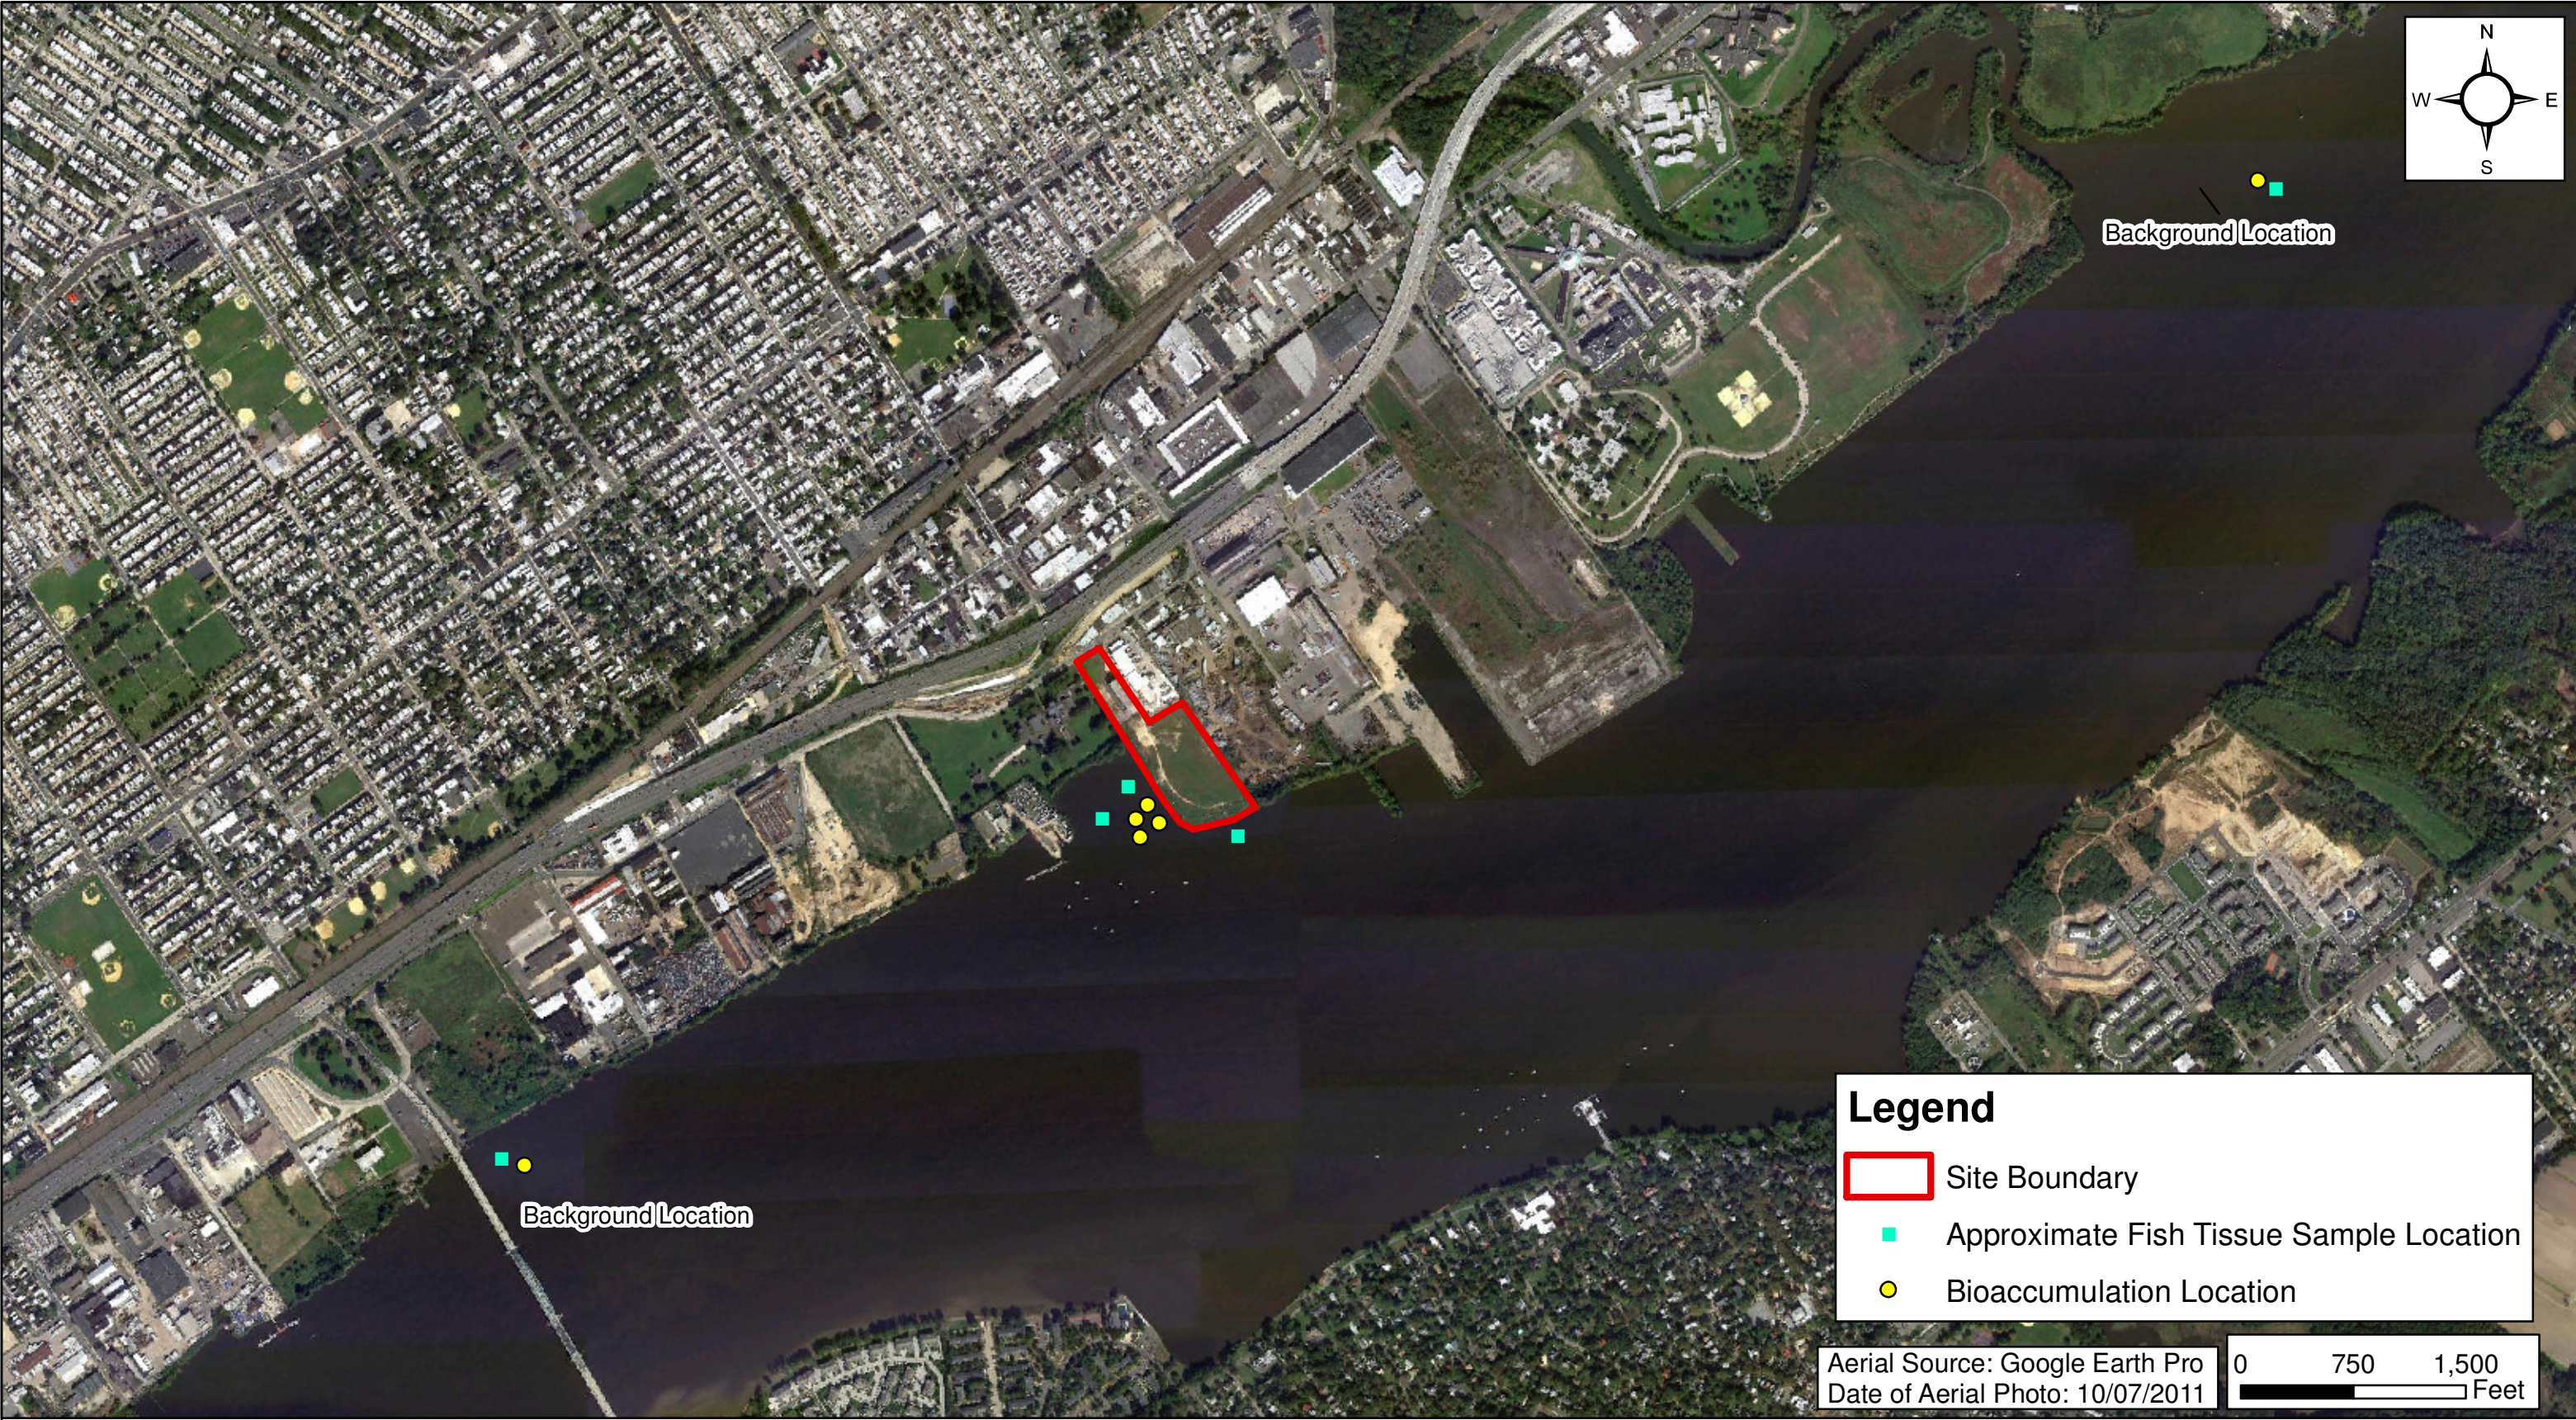
Table 2-1 summarizes the approach for the groundwater monitoring component of the LTM program. Additional details on the specific procedures and monitoring requirements can be found in the LTM WP (ARCADIS 2010, 2011) and the LTM final field sampling plan (ARCADIS 2010, ARCADIS 2011b). Analytical parameters included in the monitoring program are PCB Aroclors and semivolatile organic compounds (SVOCs). In previous years, PCB congeners and dioxins were also monitored. Groundwater monitoring well locations are depicted on Figure 2.

Table 3-1 summarizes the approach for the LNAPL trench monitoring component of the LTM program. Additional details on the specific procedures and monitoring requirements can be found in the LTM WP (ARCADIS 2010, 2011a) and the LTM final field sampling plan (ARCADIS 2010b, 2011b). Figure 2 shows the location of the LNAPL trench and trench sumps.
